SOME RECENT SHORE ICE PILE-UP AND RIDE-UP
OBSERVATIONS ALONG THE ALASKA ARCTIC COAST

Austin Kovacs

January 1982

CORPS OF ENGINEERS
U.S. ARMY COLD REGIONS RESEARCH AND ENGINEERING LABORATORY
HANOVER, NEW HAMPSHIRE

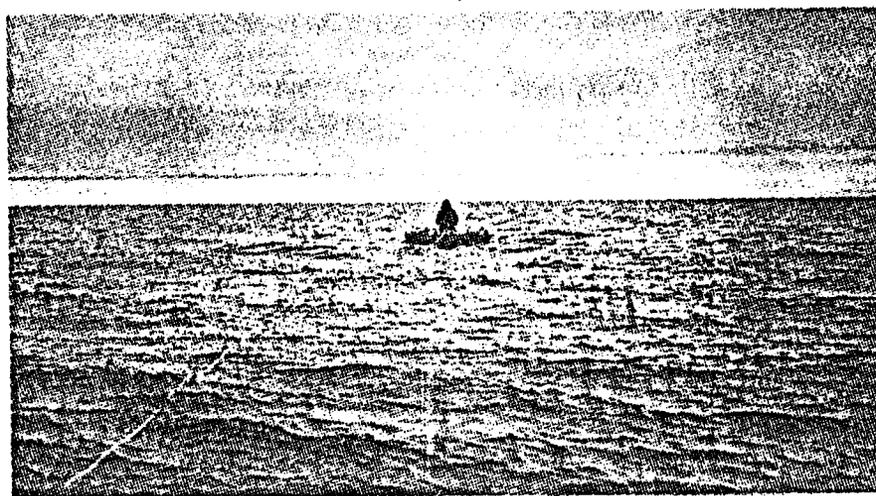
Figure 8. Sounding measurements were made from this raft. "

An elevation survey was made along the lines shown in Figures 4a and b. An elevation survey was also made of the undisturbed tundra just north of the berm beyond the B profile line drawn in Figure 3a. The bathymetry off shore was recorded by taking soundings from an inflatable raft (Fig. 8). The survey results are shown in Figure 9. The seabed near the beach is shown to slope at an angle of 8° to 10° to a depth of about 2 m. Beyond this depth, the seabed has a very shallow slope. The steeper slope near shore above the 2-m depth may be controlled in part by ice push, which transfers gravel up onto the beach. The natural or non-ice-scarred tundra surface profile (A) is shown to have an elevation which is more than twice that of the ice-scarred terrain (profile B). It should be noted that profile B does not represent the deeper area of the ice-scarred feature. The deeper area was up to 1/2 m below the pond water level.

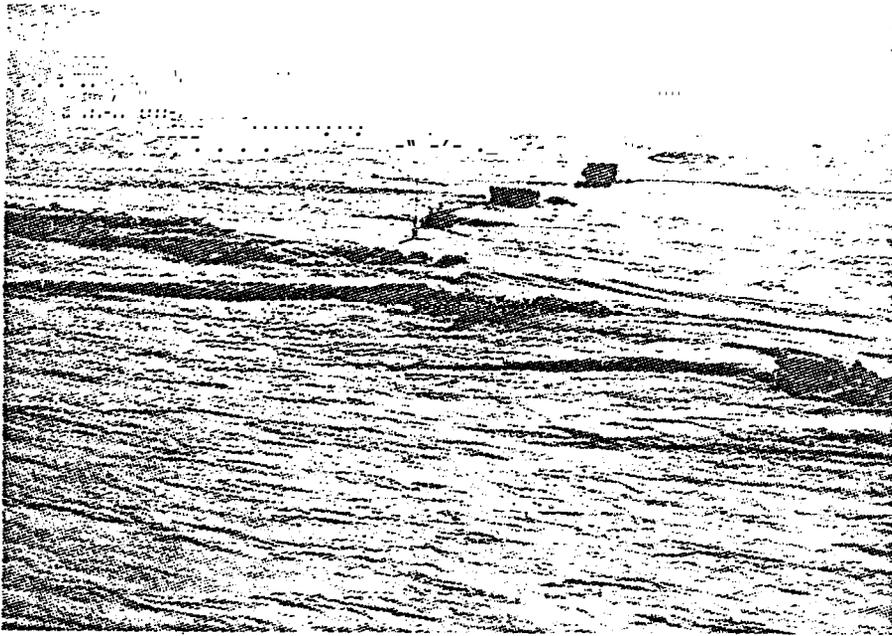
Figure 11. Shore ice pile-up near the shore facilities of the abandoned DEW Line station east of Collinson Pt.

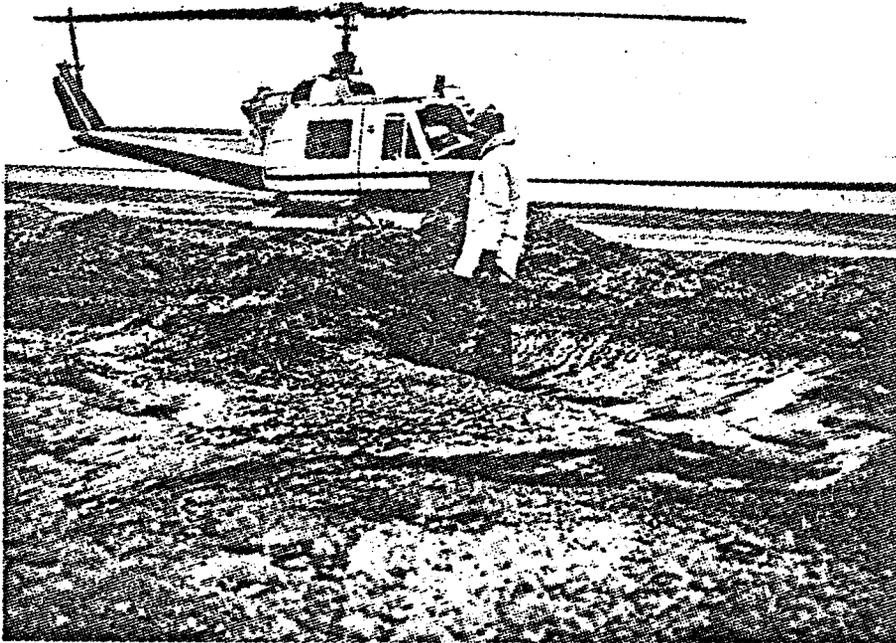
Figure 25. Gravel and pothole beach relief remaining after shore ice pile-up melted away.

On 26 June 1981, at about 10:30 am, sea ice up to 0.5 m thick moved in upon the beach along a broad section of the coast near the Lonely DEW Line station (Fig. 16). Local personnel who observed the event stated that the ice piling lasted less than 10 minutes and reached a height of 4 m (Fig. 24). In August we measured the ice-pushed gravel relief and found that the ice had dozed up beach material consistently for a distance of 30 m from the water's edge along more than 500 m of the shore. The longest inland ice advance as determined by ice scar length was 59 m. No ice remained exposed on the beach in late August. Ice was found, however, under several of the ice-push gravel piles, such as the pile shown in Figure 25.

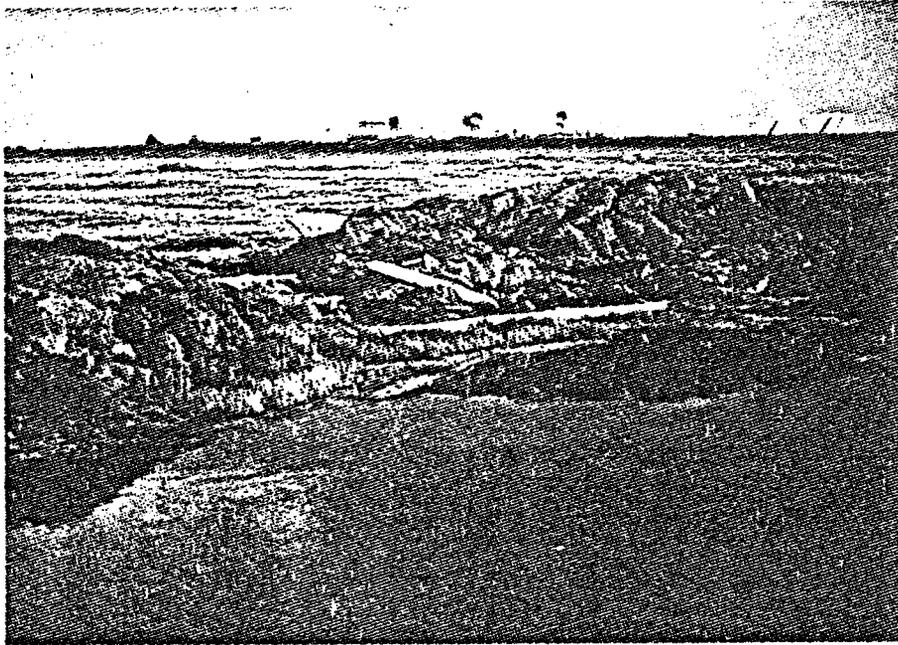
Figure 27. Ice-pushed tundra berms in a and b are features 1 and 2 shown in Figure 25.

Along the beach near the Lonely DEW Line station, we discovered several old ice scars which were not detected on previous recon flights (Fig. 26). The distance inland of the ice-push feature furthest from the sea was 85 m. Ground views of the ice-pushed tundra berms (1 and 2) shown in Figure 26 are presented in Figure 27. These berms were impregnated with driftwood, which was incorporated into the soil during ice dozing.

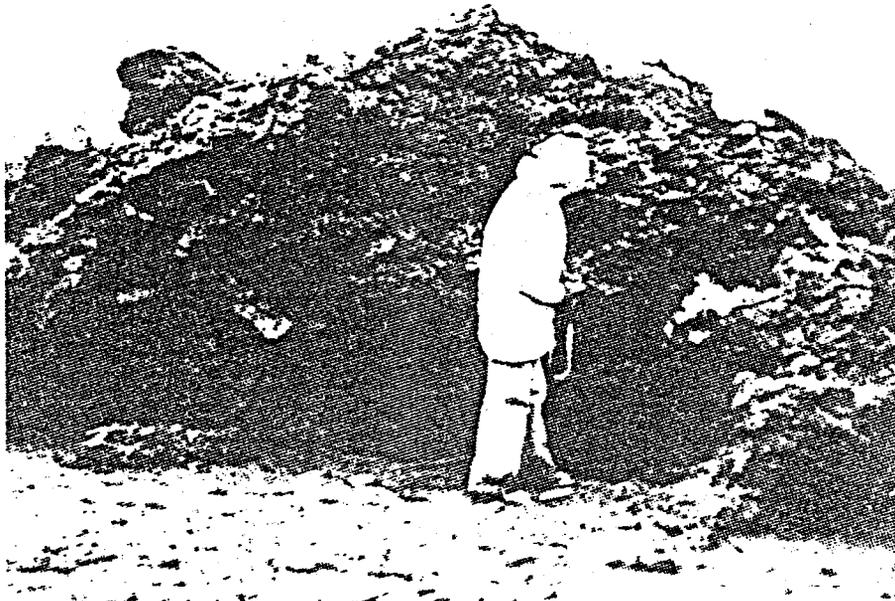
Figure 29. Ice-pushed silt and peat pile on Drew Pt. spit. White area in front of observer is ice.

measured the furthest inland ice push berm to be 56 m. The spit was found to consist for the most part of peat and fine-grained silt. The ice had pushed this material into piles up to 1.5 m high. Sea ice and driftwood were found incorporated into the debris of the larger piles (Fig. 29). In some locations large slabs of organic material about 0.25 m thick had been displaced (Fig. 30) and stacked layer upon layer (Fig. 31). This area of the coast is receding at a rate of 6 to 10 m per year. Therefore, summer storms and coastal currents rapidly modify the coastline and in so doing remove ice ride-up scars on the land.

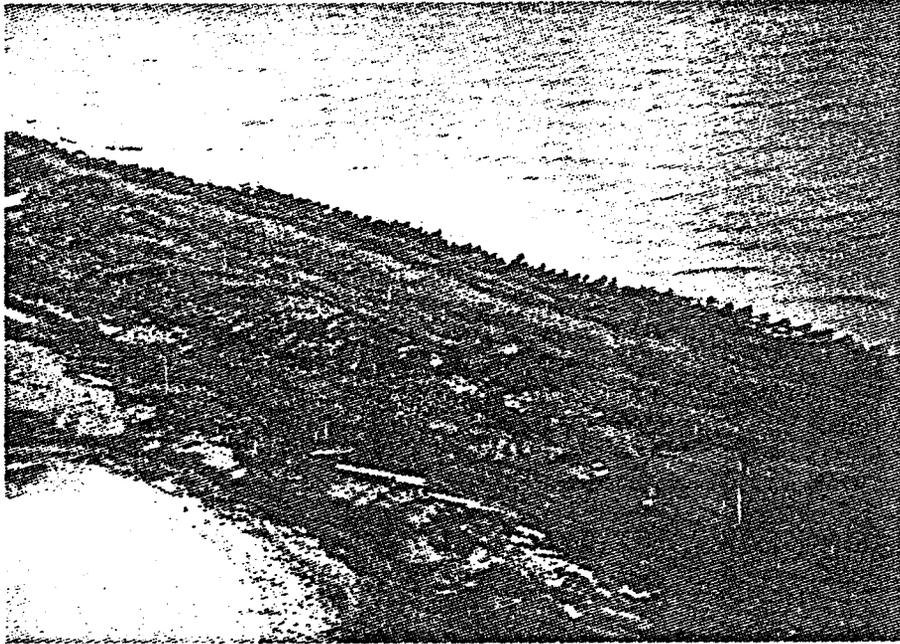
Figure 30. Slabs of peat displaced by ice-push on Drew Pt. spit.

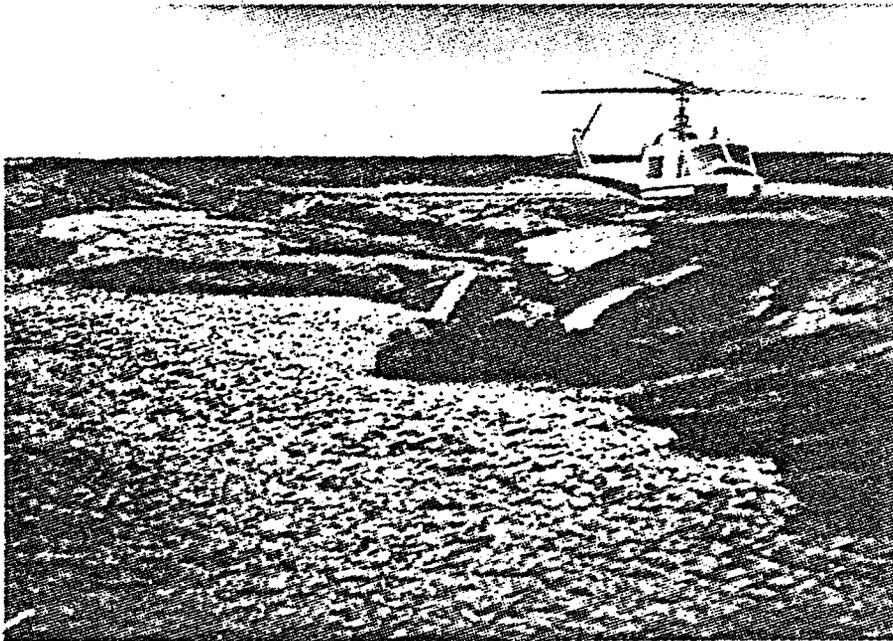
Figure 31. Peat slab piles on Drew Pt. spit.
