SEA ICE RUBBLE FORMATIONS IN THE BERING SEA AND NORTON SOUND, ALASKA

CRREL
Special Report 81-34

UNITED STATES ARMY CORPS OF ENGINEERS
COLD REGIONS RESEARCH AND ENGINEERING LABORATORY
HANOVER, NEW HAMPSHIRE, U.S.A.

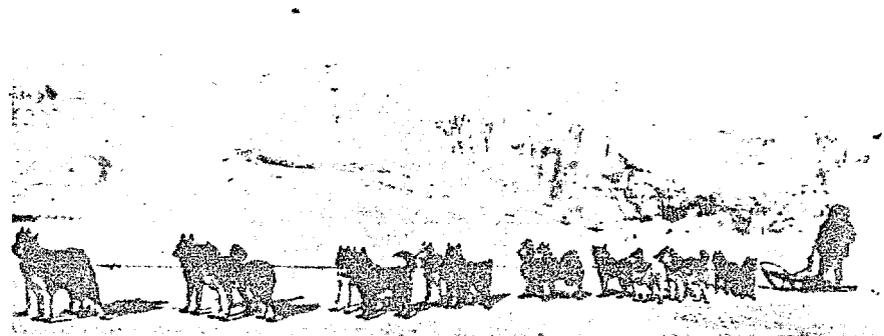
b. View of a grounded ice formation near Nome, Alaska, in spring of 1910.

Figure 1. Photographs of Bering Sea pressure ridges taken in early 1900s (courtesy of G.K. Sherrod, Nome Museum).

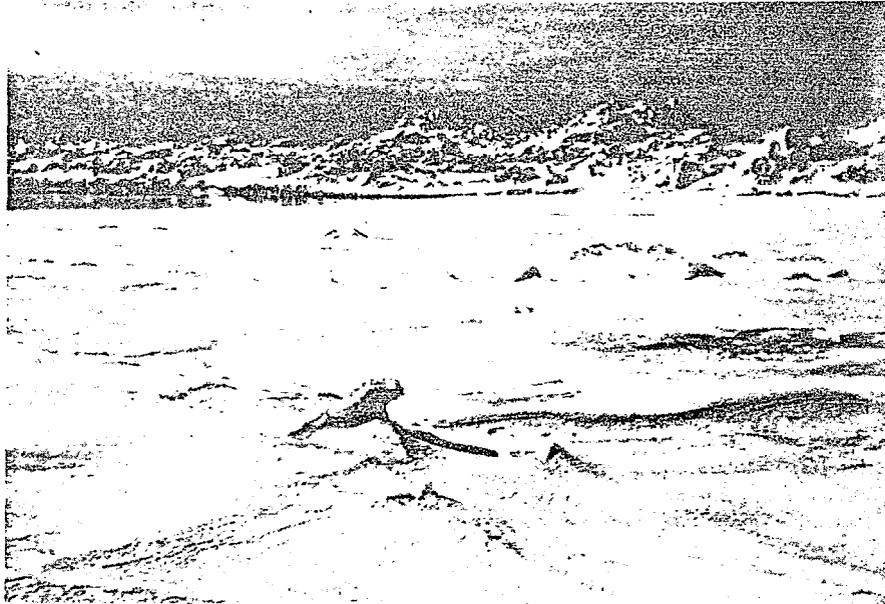
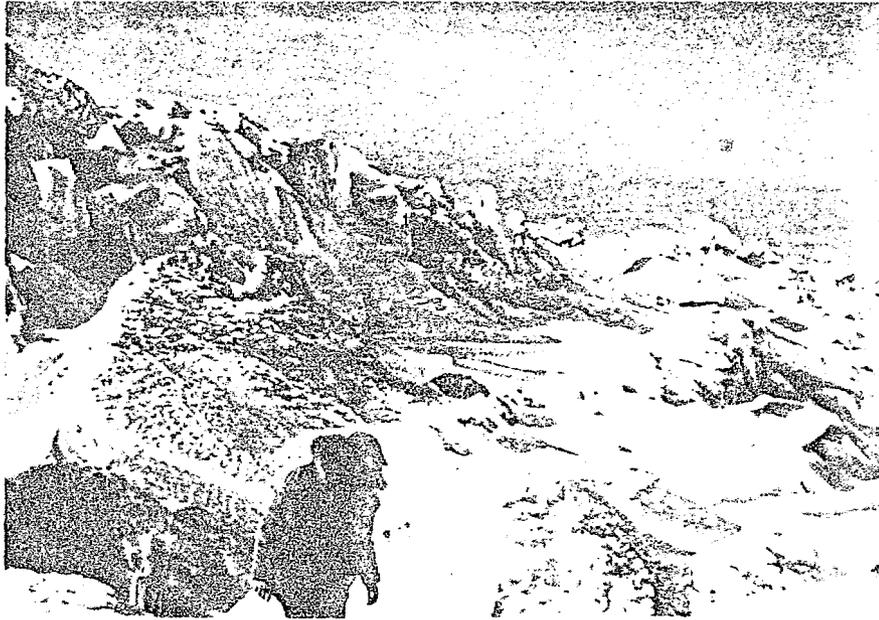
Figure 4. Grounded ice formation one.

a. Aerial view.

b. Ground view (arrow points to man).

c. Close-up view showing ice block thickness variation and dirt incorporated in the ice rubble.

The first ice rubble pile visited is shown in Figure 4. The fast ice was in contact with this formation only at the southeastern end. Drift ice along the north side was estimated to be moving westward at 3 to 4 knots. The formation was estimated to be 75 m wide and over 250 m long. It consisted of ice blocks typically 35 cm thick, but many ice blocks over 1 m thick were noted (Fig. 4c); the thicker ice consisted of previously ridged and rafted ice fragments. The ice formation was grounded in 4.1-m-deep water and reached a height of over 14 m.

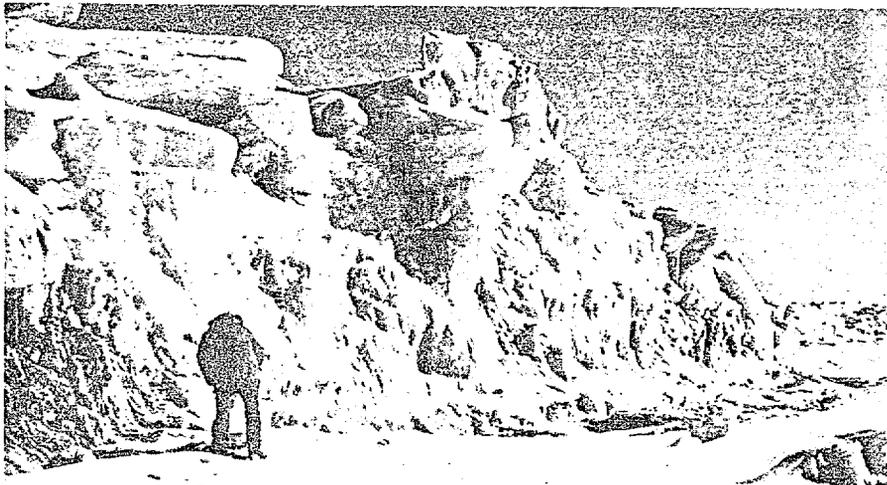
Figure 5. Grounded ice formation two.

a. Looking south.

b. Surface view of the south face of the ice rubble.

Ice formation two (Fig. 5) was grounded in 6.0-m-deep water and was 12 m high.

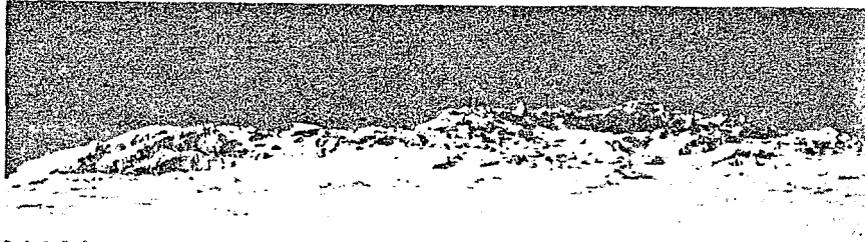
Figure 7. Grounded ice formation four (top). Note man on top of ridge and dirt incorporated in the ice rubble (bottom).

Ice formation four (Fig. 7) comprised ice blocks 25-30 cm thick; it had a ridge height of 13 m and was grounded in water 7.5 m deep.

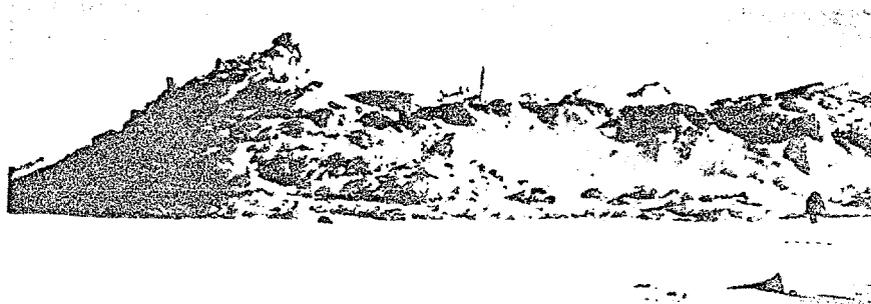
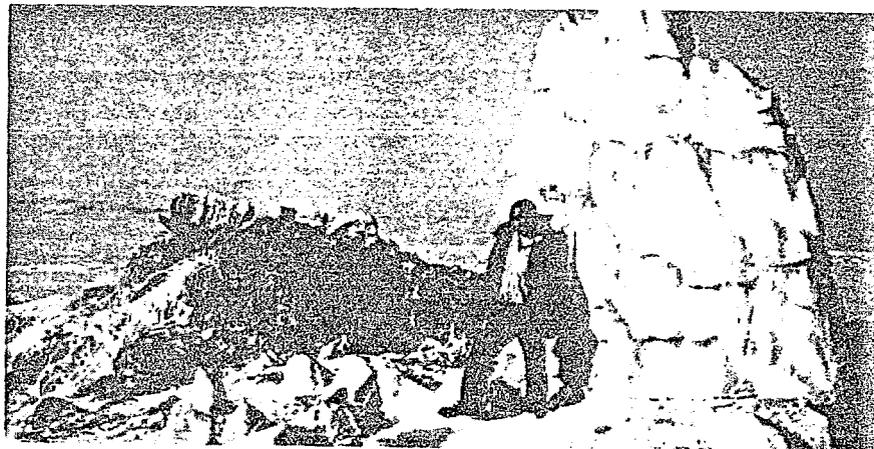
Figure 8. Grounded ice formation five. "Note the dirt incorporated in the ice rubble. The vertical ice sheet was highly fractured and scoured as a result of being pushed upward through the surrounding ice blocks. Ice block width:thickness aspect ratio in the sheet was 1:1 to 1:1.5.

Ice formation five (Fig. 8) consisted of ice blocks 30 to 35 cm thick and it was estimated to be 75 m wide and 200 m long. The vertical ice sheet behind the observer extended 3.8 m above the 13-m-high ice rubble at its base. The water depth beside the ridge was 3.1 m.

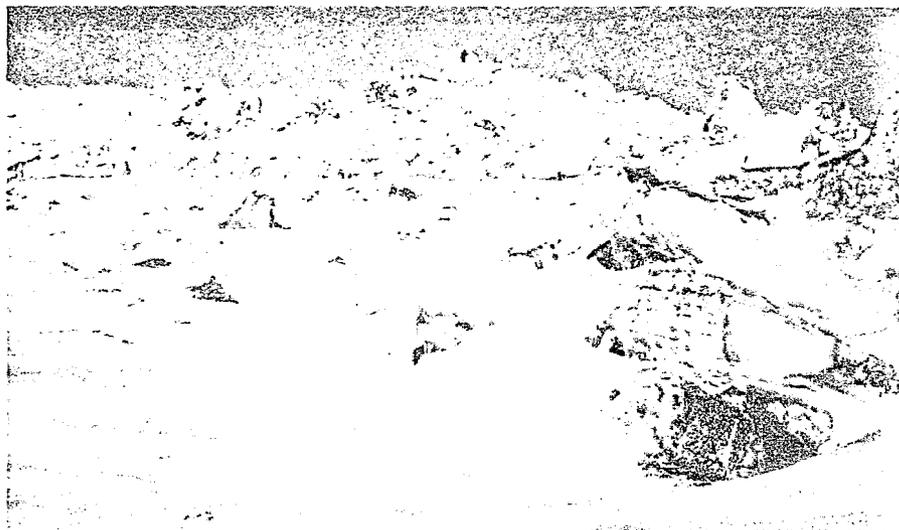
Figure 11. Grounded ice formation seven. In aerial photograph, fast ice is to left, pack ice to right.

Ice formation seven is shown in Figure 11. The average ridge height in this formation was estimated to be between 5 and 6 m and most of the ice blocks were 30 to 45 cm thick. Some, from pressure ridges or previously rafted ice, were over 1 m thick. The highest

ridge was 17 m high. A sounding taken beside the ridge gave a water depth of 11.2 m.

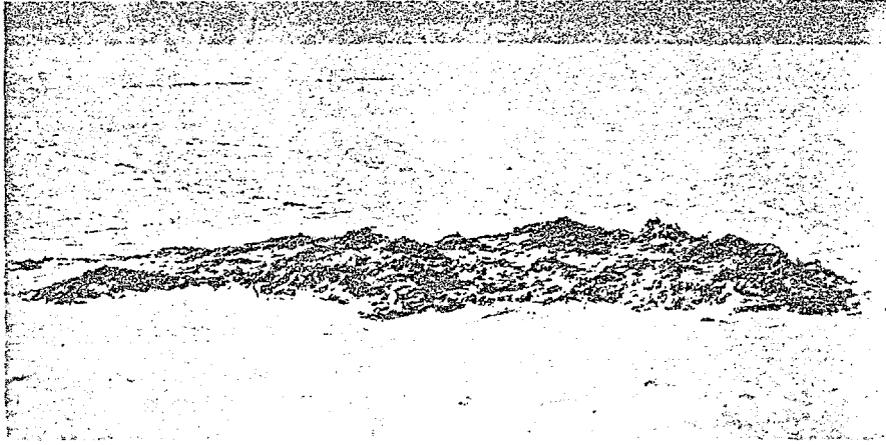
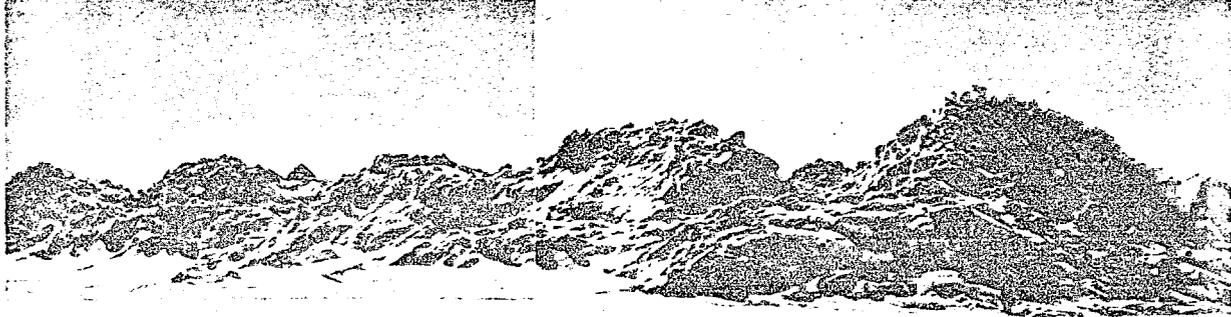
Figure 12. Grounded ice formation eight. Note ice rubble and dirt.

Ice formation eight (Fig. 12) was grounded in 3.0-m-deep water. It was approximately 150 m by 200 m in size and had a peak ridge elevation of 11.5 m.

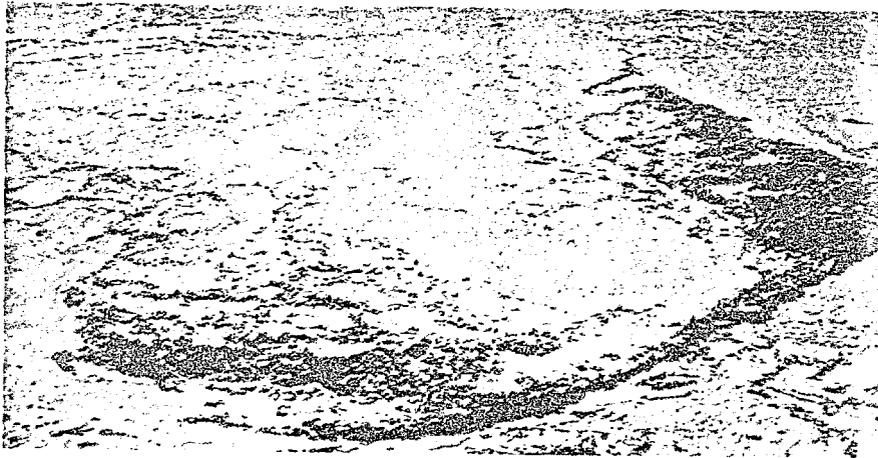
Figure 14. Grounded ice formation ten (at extreme right).

Ice formation ten (Fig. 14) was grounded in 4.5-m-deep water. Ice blocks in this formation varied from 40 cm to 2 m in thickness and formed ridges up to 9 m high.

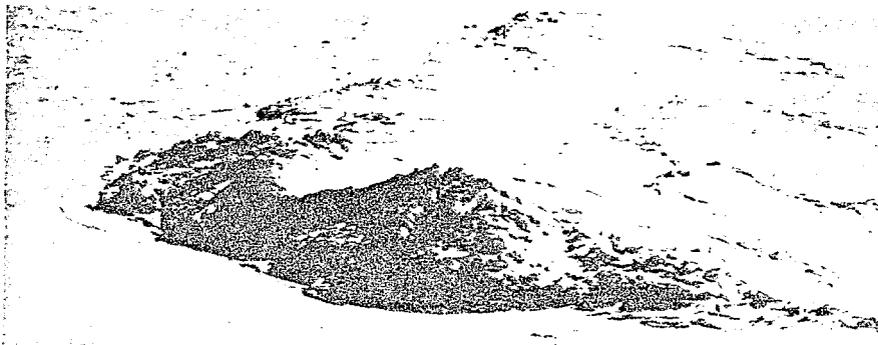
Figure 15. Grounded ice formation eleven.

a. Aerial view.

b. Refrozen fragmented ice in ridge core.

c. Portion of original ice sheet.

Ice formation eleven (Fig. 15) was 9 m high and was grounded in 8.5-m-deep water near position C in Figure 2. Collapse of a portion of the ridge revealed a core of fragmented ice blocks refrozen into a solid mass (Fig. 15b). On the left side of the ice formation the

30-cm-thick ice sheet from which the pressure ridge formed could be seen (Fig. 15c).

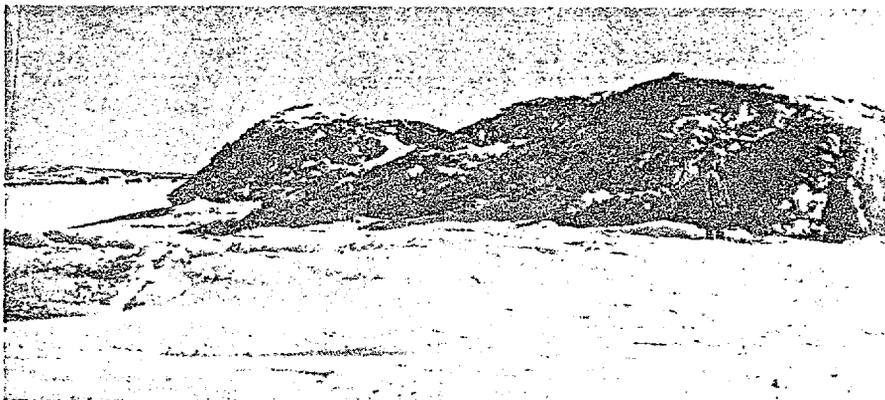
Figure 16. Air (top) and surface (bottom) views of grounded ice formation near Stebbins. The village is along the coastline at upper left in both-photographs.

We also observed grounded ice formations in fairly sheltered locations, such as one over 3.5 m high in 3.9 m of water near the village of Stebbins (Fig. 16). This ridge was composed of ice blocks 10 to 15 cm thick. In another somewhat sheltered area off the southeast coast of Isaacs Pt. (Fig. 2) four grounded ice formations were observed, each 4 m or more in height. These formations are shown in Figure 17. The largest one in area was grounded in 2.6 m of water.

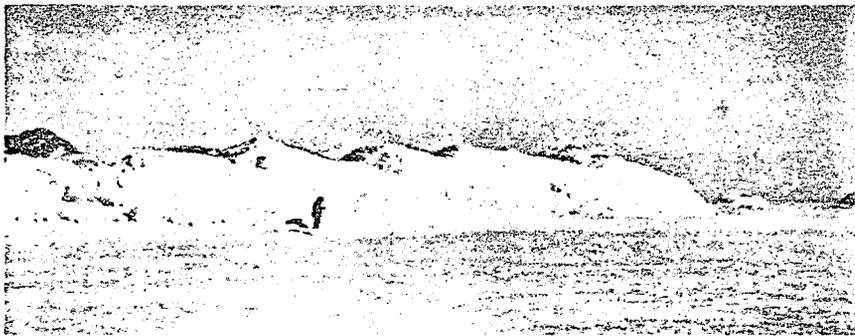
Figure 17. Four grounded ice formations near Isaacs Pt. (extreme upper left in top photo, and at left behind the near ground ridge formations in bottom photo). Two other formations are shown in the distance at the right in bottom photo. Note the dark color of the second largest ridge which is due to sediment in the ice rubble.

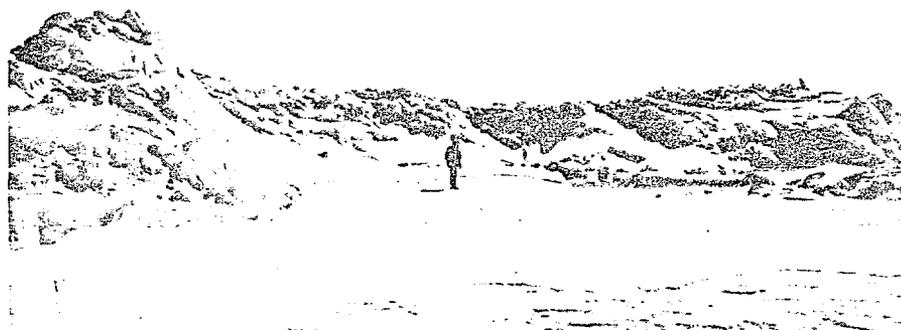
Figure 19. Five-meter-high ice formation grounded in 6.3 m of water off Port Clarence.

Sledge Island, off Port Clarence spit (Fig. 19) and along the coast between Cape York and Cape Prince of Wales.

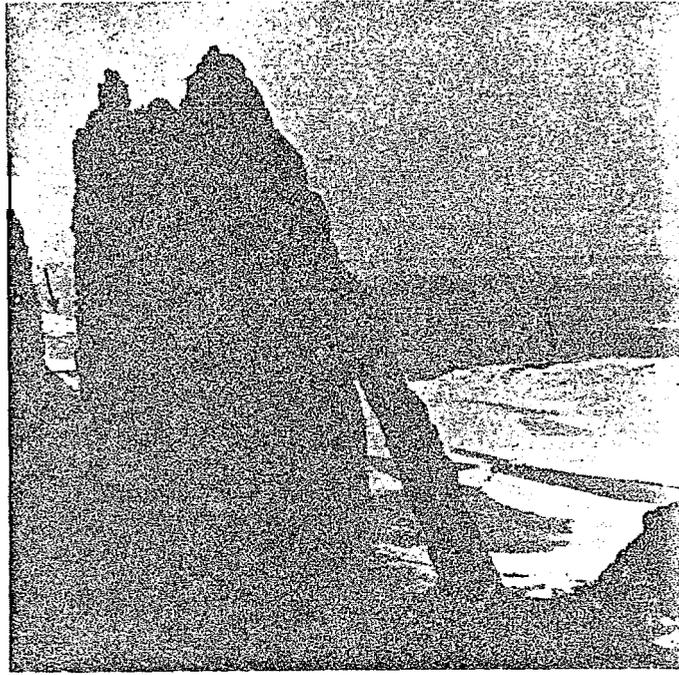
Figure 20. A view from Bull Sea Point on the northeast coast of St. Mathews Island in the southeastern Bering Sea showing several offshore grounded ice rubble formations (see arrows). (Photo source, 1976 Arctic Bulletin.)

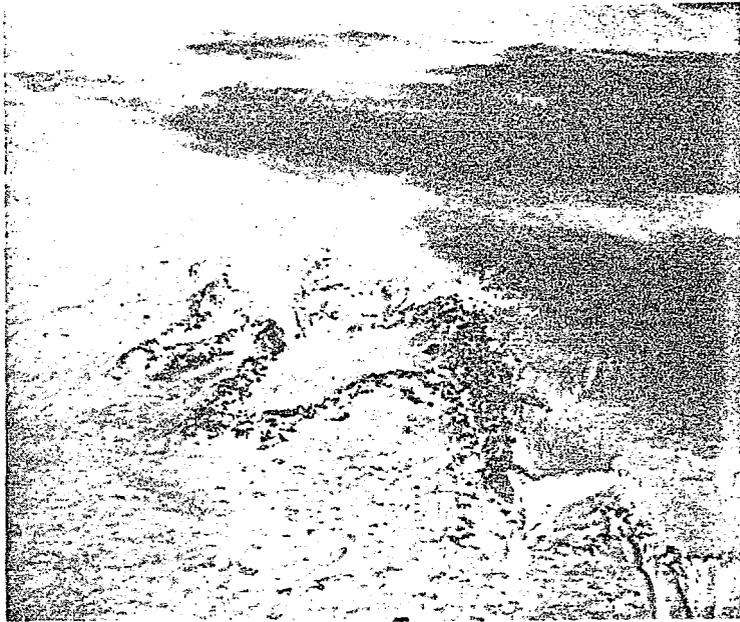
Figure 21. Typical sediment-laden ice ridge formations.

Most of the grounded ice formations were found to be quite dirty (Fig. 21). **Some** of this material was incorporated into the ice during growth, either **by** the freezing of silt-laden water or by the incorporation of dirt-laden **frazil** ice into the growing ice sheet. Drake et al.⁴ have **shown** that significant suspended sediment exists in the water beneath the ice in the Yukon River Delta region during the winter. However, most of the dirt observed in the ice rubble was the direct result of ice interaction with the **sea** floor. During ridge-building, portions or fragments of the ice sheet were forced downward against the seabed and then pushed back upward, bringing sediment with them to all parts of the rubble pile. Through this action sediment is gouged up and redistributed by ice or current transport.

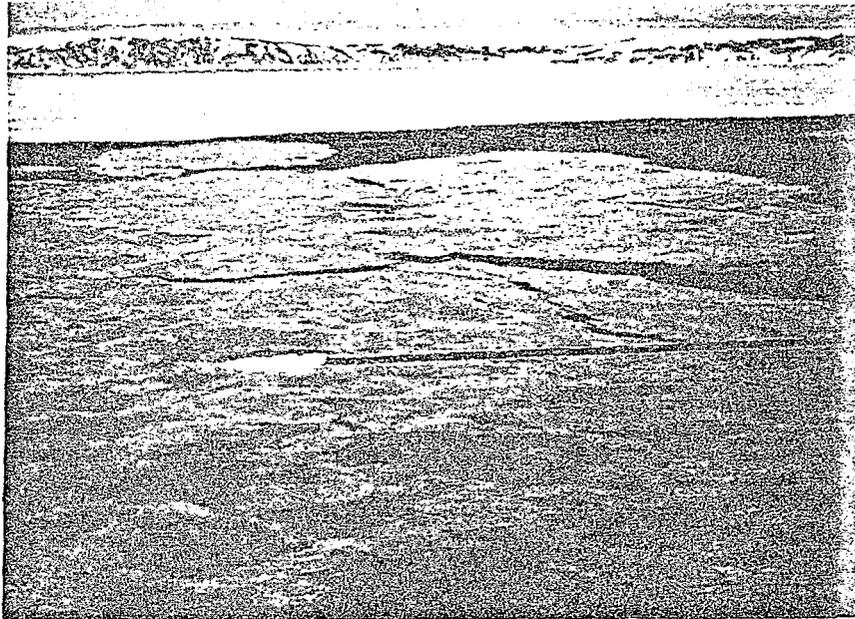
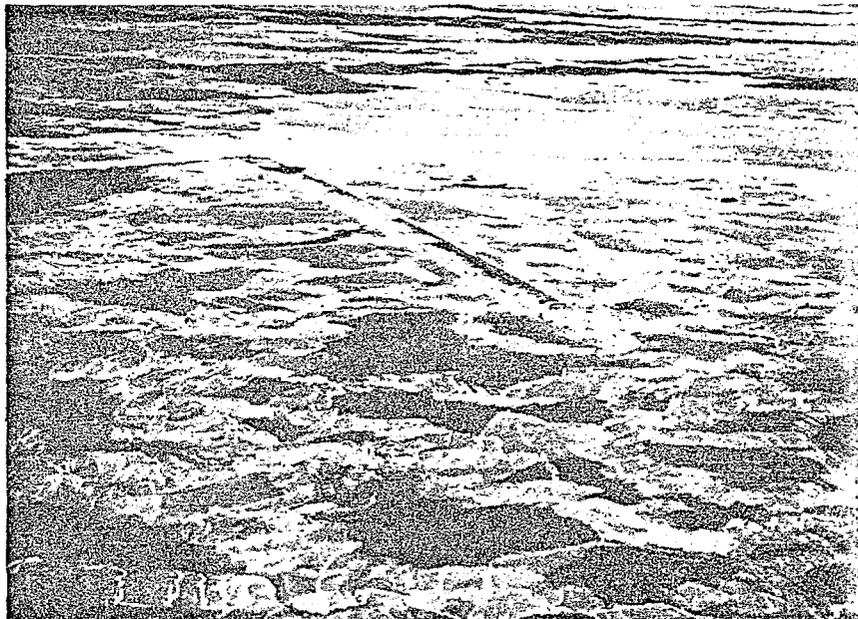
Figure 24. Ice formation believed to be moving with the current through thin ice.

second ice formation (Fig. 23) was observed moving with a broken ice field near position C in Figure 2. Another observed from the air (Fig. 24) appeared to be sailing westward through thin ice west of Rocky Point. However, this was not verified by observations from the fast ice as a landing could not be made. The following personal accounts of large ice formations sailing about are of interest.
