Recent Shore Ice Ride-up and Pile-up Observations

Part I

Beaufort Sea Coast, Alaska

Austin Kovacs

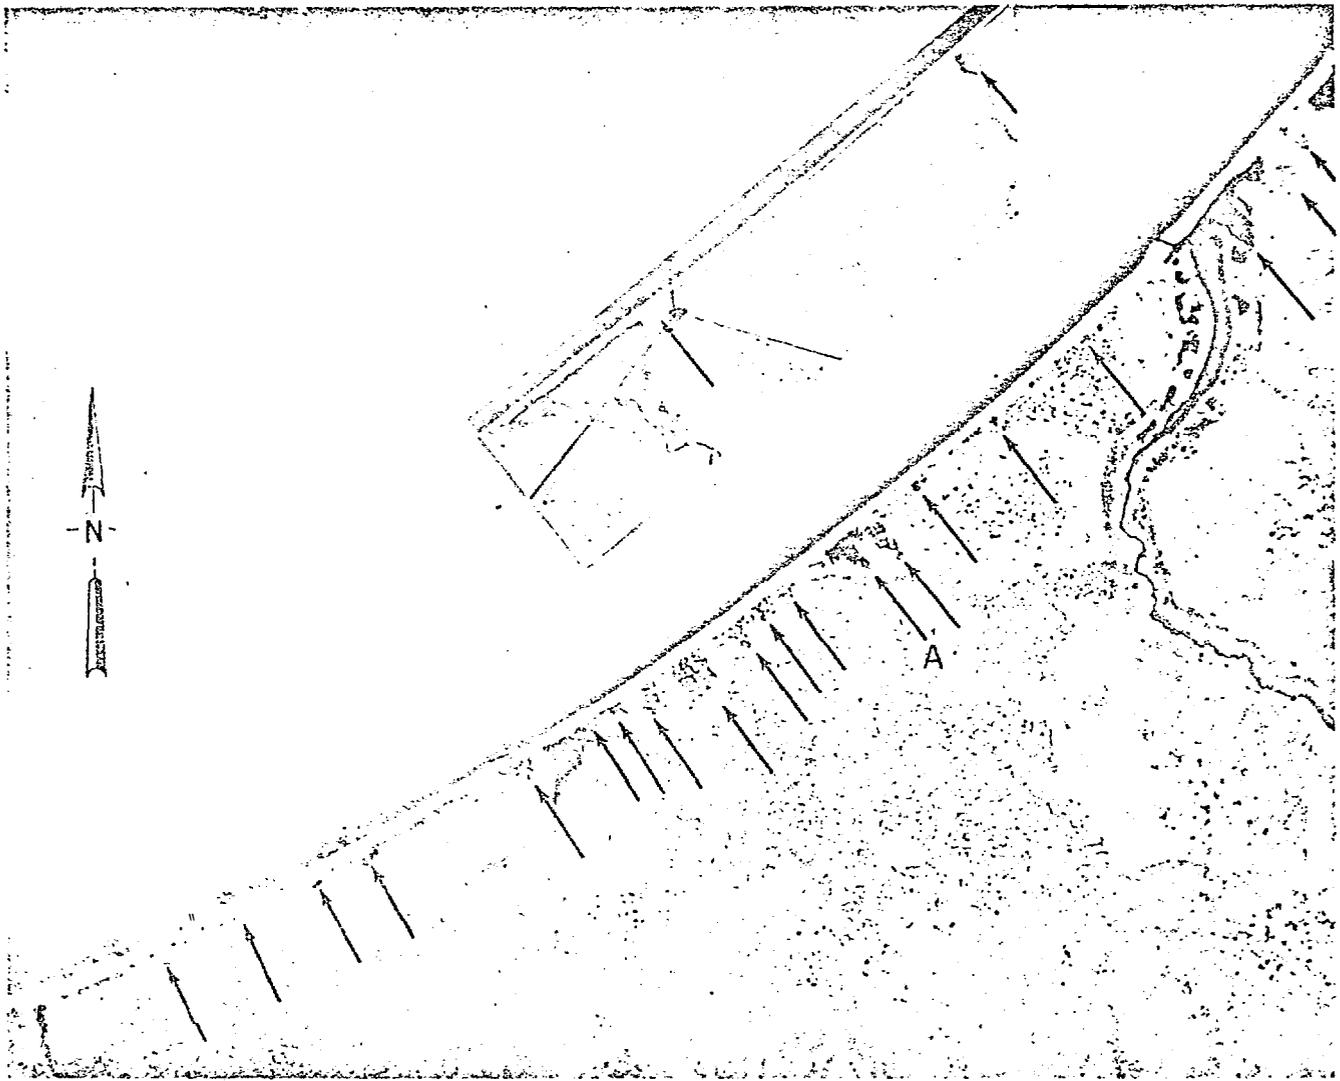
The ages of these ice-scarred features are unknown. **A July** 1950 view of the coastline (Fig. 35) shows the features existed at that time, and ice ride-up had intermittently scarred the tundra **along** a 2.9-km section of the coast. A 194³~~7~~ image of this coastline revealed the same scars. The features are therefore over 35 years old. We estimate from 1950 and 1981 aerial photos **that** the shoreline is receding at 0.35 m per year, or ¹⁴ ≈ 12 m since 194³~~7~~. The ice-push berms we measured were therefore farther from the water in 194³~~7~~ than they are today.

The pond at arrow A in Figure 35 is in the ice scar shown in Figure 29a. It is interesting that this feature appears on maps **as** a pond (Anon., 1976). This **may** be the **only** pond ever shown on a map which **was** formed as a result of an ice ride-up. **We** have named this feature **Ice Scar Pond** in Figure **8**.
