# Archaeological Analysis of Submerged Sites on the Gulf of Mexico Outer Continental Shelf

Prepared under BOEM Contract  
M09PC00048  
by  
Tesla Offshore, LLC  
36499 Perkins Road  
Prairieville, LA 70769

**U.S. Department of the Interior  
Bureau of Ocean Energy Management  
Gulf of Mexico OCS Region**

**New Orleans, LA  
August 2013**

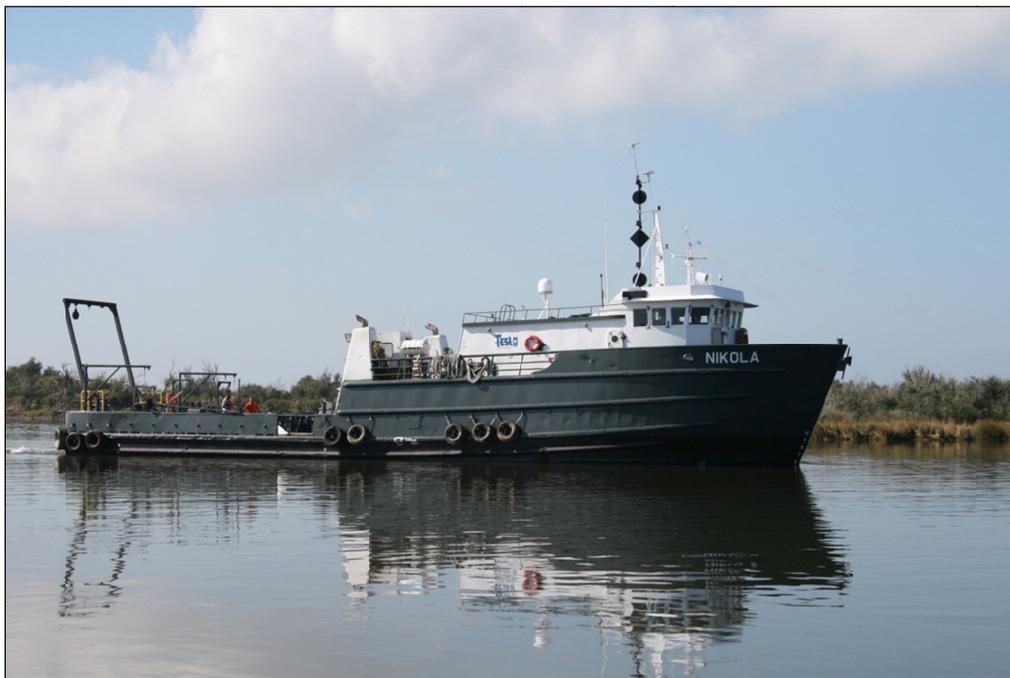
Figure 2.1. Geophysical survey vessel M/V *Nikola*.

All geophysical data acquisition was performed aboard the motor vessel (M/V) *Nikola* from March 5, 2010 to June 7, 2011 (Figure 2.1).

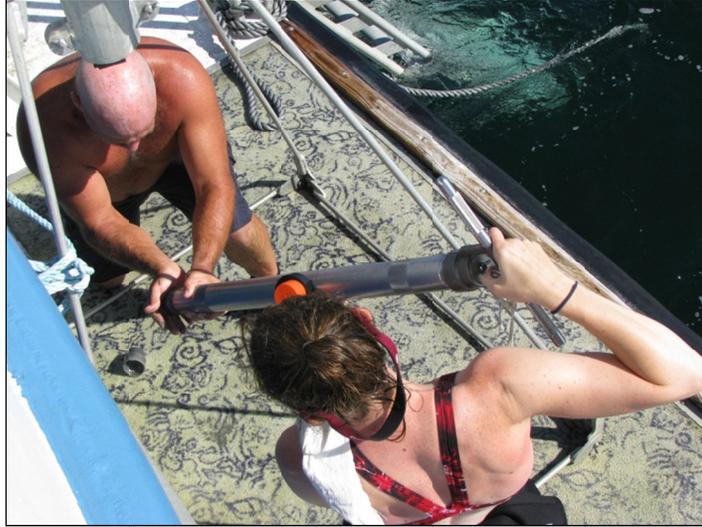
Figure 2.4. Bill Neal and Amanda Evans remove a core sleeve from the 36" corer.

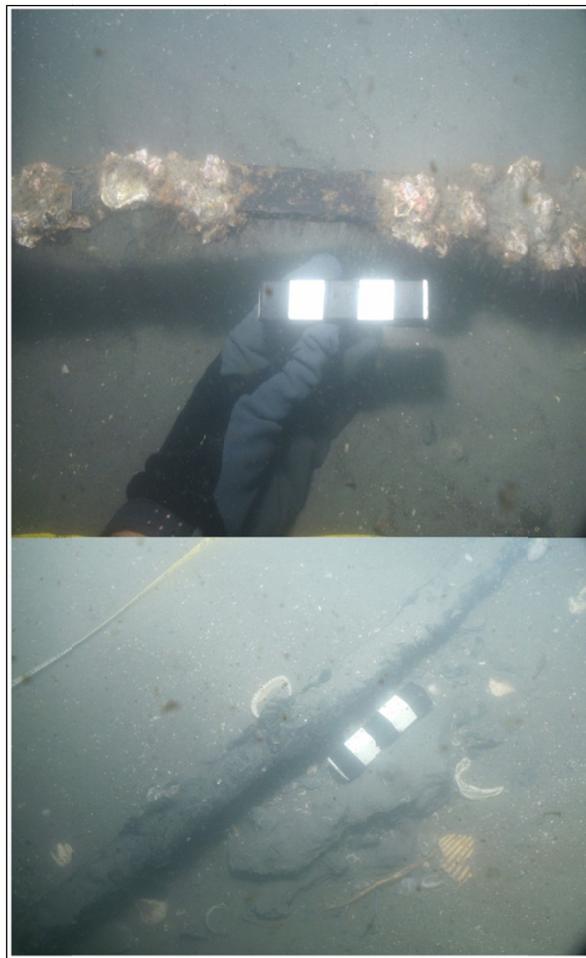
Figure 3.1.5. Photographs of metal band. 10 cm scale bar in 2 cm intervals.

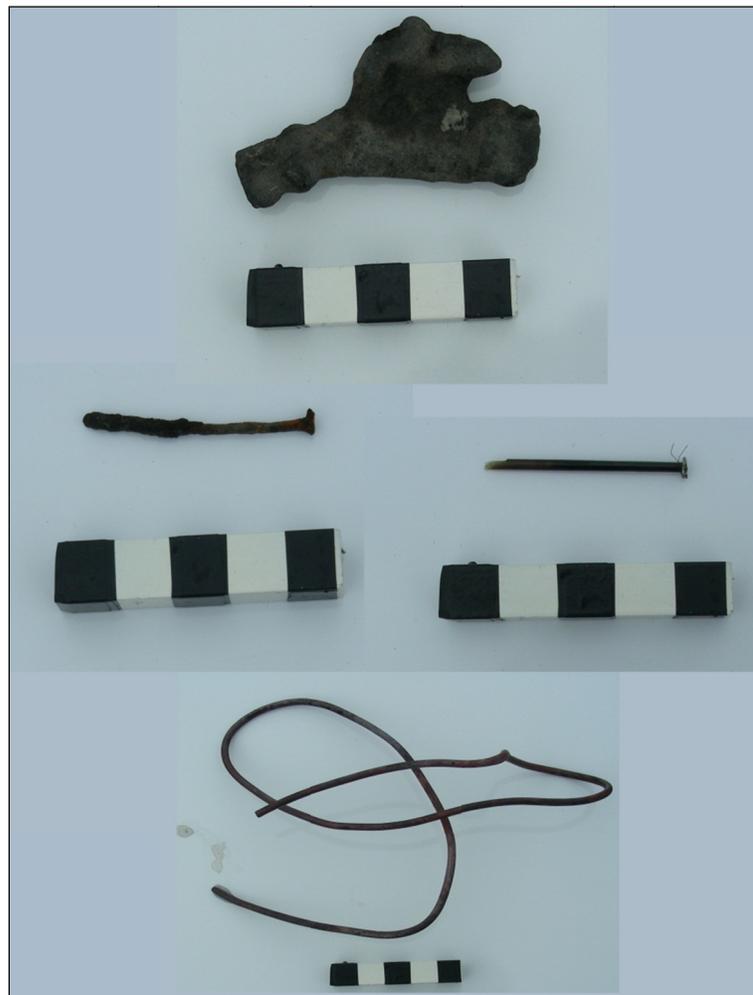
Figure 3.1.6. Photograph of concretion (at top), copper tubing (at bottom), and objects recovered from inside concretion (middle). 10 cm scale bar in 2cm intervals.

A baseline was established along the band to facilitate additional circle searches at either end using the hand-held metal detector. These searches were extended in each direction beyond the band. The metal detector searches produced a few weak targets which, after investigation, proved to be random modern wire nails, beer cans, copper tubing, fragments of fiber-optic cable, small metal/shell concretions, and a fragment of a modern wooden board measuring 10.2 cm (4 inches) by 2.5 cm (1 inch). There was no indication of any intact wooden structure; instead, the site appeared to be a debris field of random, discarded material. One of the small concretions was recovered after its location was noted. The concretion was carefully opened on the dive vessel. Objects within the concretion included a plastic housing and a modern wire nail (Figure 3.1.6).

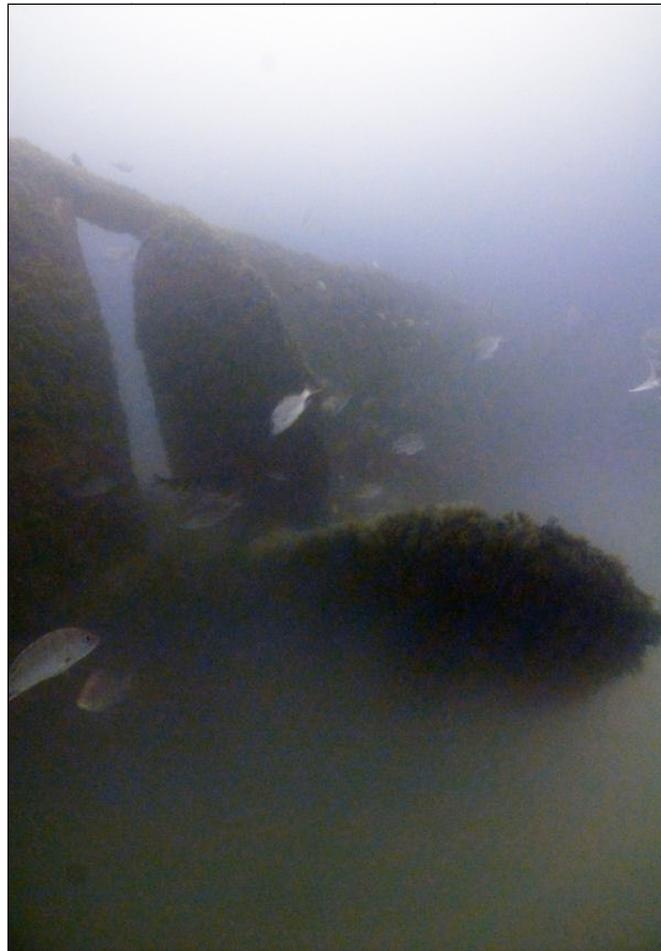
On the starboard side, the hull breach measures nearly 4.3 m (15 ft) at the largest observable point, while the port side breach measured 8.4 m (28 ft) at the turn of the bilge, and actually grew larger as the hull extended downward into the sediment. Divers noted that they could see clearly through, from the port side to the starboard side of the hull, at this breach. The hull plates appear to bend inward on the port side, and outward on the starboard side, lending credence that this damage was, in fact, caused by a powerful explosion, and not merely due to post depositional deterioration. The ship's rudder and propeller were mapped in detail. The rudder extends from the keel of the vessel down into the seafloor and measures 3 m long by 3 m deep (9.84 by 9.84 ft). The propeller contained a four-blade configuration with individual blades measuring 2.5 m long and 1.34 m wide (8.2 by 4.4 ft) (Figure 3.2.11)

Figure 3.2.11. Propeller blades. (Photograph courtesy of Colm O'Reilly.)

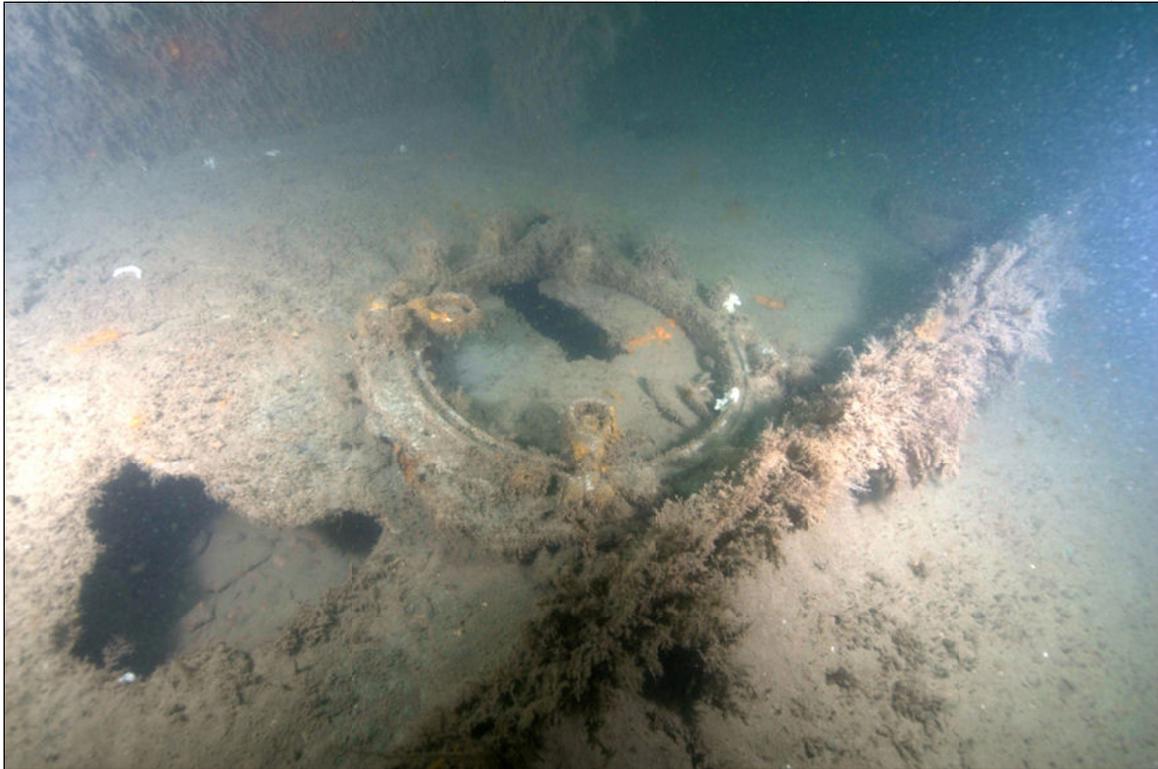
Figure 3.7.5. Porthole resting on deck. (Photograph Courtesy of Colm O'Reilly.)

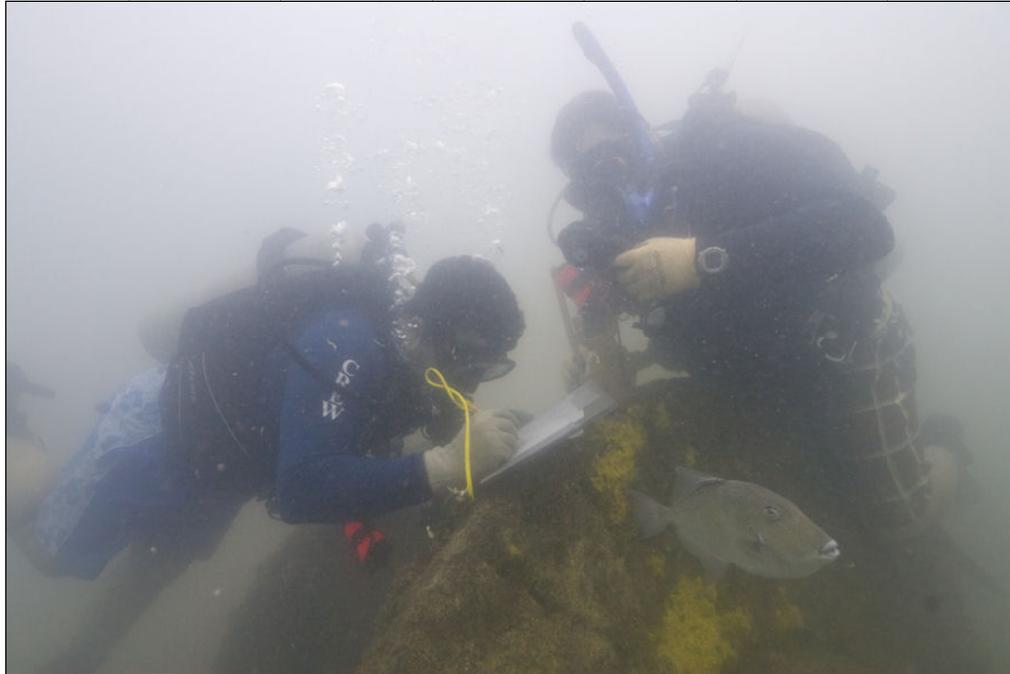
Figure 3.8.1. Divers Andy Marr and Jake Shidner mapping the starboard paddlewheel. (Photograph courtesy of Colm O'Reilly.)

*Paddlewheel Components:* The most evident portion of the extant vessel is the paddlewheel shaft, which lies in a north-south orientation and terminates at either end with the paddlewheel hubs (Figures 3.8.1, 3.8.2, and 3.8.3). The shaft is 30 cm (12 in) in diameter, but increases to 50 cm (19.5 in) near the paddlewheel hubs. The entire shaft, extending from the southern hub to its northern counterpart, measures 13.3 m (43.5 ft). The paddlewheel hubs are composed of an inner and outer hub, which form a 1-m (3.25-ft) space for the paddle arms and buckets; both hubs are 1.9 m (6.25 ft) in diameter. The northern paddlewheel hub includes partial remains of paddlewheel spokes and at least one partial bucket. The spoke measures approximately 4 m (13 ft) in length, and the broken bucket fragment is 0.5 m (1.6 ft) wide.

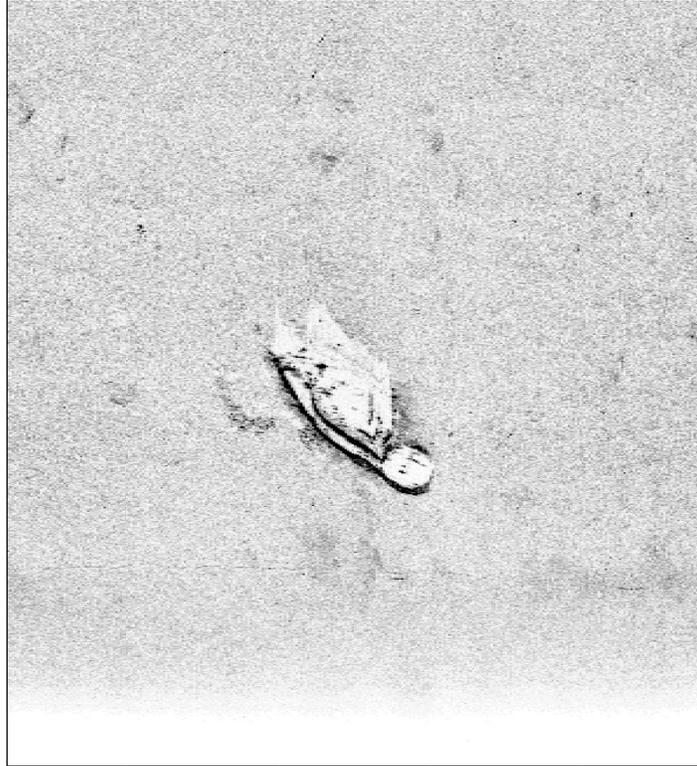
Figure 3.10.1. 410 kHz side scan sonar image of Site 322 from survey Line 305. Oriented north up (Floyd 2005).

While conducting subsequent operations in the area in 2005, Tesla Offshore, LLC, ran six survey lines over the wreck site to provide additional imagery of the wreck (Floyd 2005; Figure 3.10.1). The wreck is oriented with the bow facing the NW. Based on the 2005 data set, the wreck measured approximately 17.3 m (57 ft) in length, 3–3.9 m (10–13 ft) in width, and rises off the seafloor approximately 0.6 m (2 ft) at the bow. The stern has subsided into the sediments. Only the “pilothouse” portion sits 0.6–0.9 m (2–3 ft) above the deck.

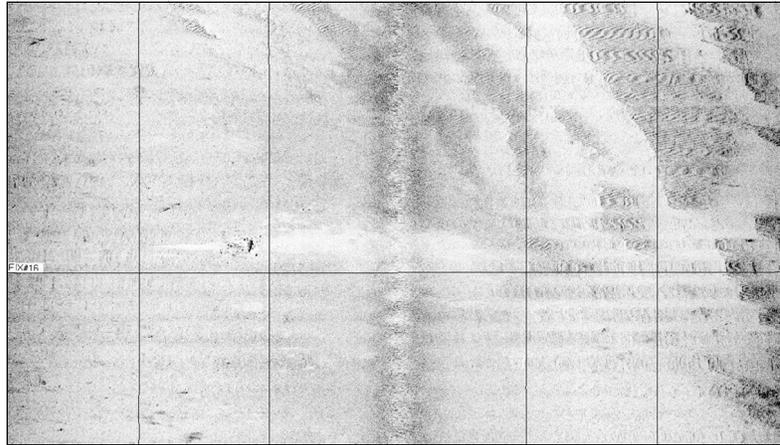
Figure 3.11.1. 410 kHz side scan sonar image of target No. 7 from survey Line 88. Oriented west up (Evans et al. 2007).

The study site located in West Cameron Area was previously identified by a geophysical survey performed in 2007 by Tesla Offshore, LLC. The resulting report was prepared by Marine Archaeologist, Amanda Evans; Marine Geophysicist, Erika Geresi; and Marine Geophysicist, J. Wyn Prior (Evans et al. 2007). Target no. 7 was identified as a potentially significant object that warranted avoidance (Figures 3.11.1 and 3.11.2). According to the report, the target:

...appears to be a significant compound target consisting of several discrete parts which are observed from different angles on four survey lines. The target covers an area of approximately 44' x 47' with a maximum recorded relief of 5'. The largest single feature within the target measures approximately 17' x 6' as recorded from survey line 102. Target no. 7 is associated with a cluster of unidentified magnetic anomalies including #120, 124, 127, 128, and 136, and should be avoided by a distance of 1,000'. Sonar target no. 7 may represent a disarticulated shipwreck or ballast pile. (Evans et al 2007 Appendix F:3)

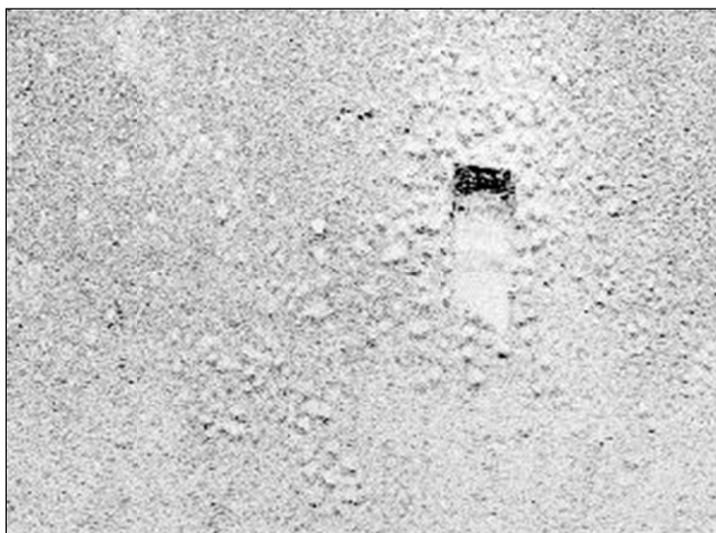
Figure 3.11.3. 410 kHz sonar image of sonar target No. 9 from survey Line 20. Oriented north up (Evans and Bronikowski 2010).

Additional geophysical data acquisition was not part of the current contract; however, Tesla Offshore was contracted by an operator to conduct a subsequent survey over this area following 2010 field study operations. The field-investigated target was “boxed-in,” providing supplemental high resolution sonar data over the site. The new sonar imagery indicated that only a rectangular target was evident, measuring 5.5 m (18 ft) by 1.8 m (6 ft) and sitting 1.2 m (4 ft) above the seafloor (Evans and Bronikowski 2010). The 2010 survey report referred to the field-investigated feature as Sonar Target No. 9. Although it is possible that the site has been altered by hurricane or anthropogenic processes, a re-examination of the 2005 data suggests that areas of dense seafloor texture, immediately apparent on the higher resolution 2010 data, may have given the incorrect impression of a multi-component site.

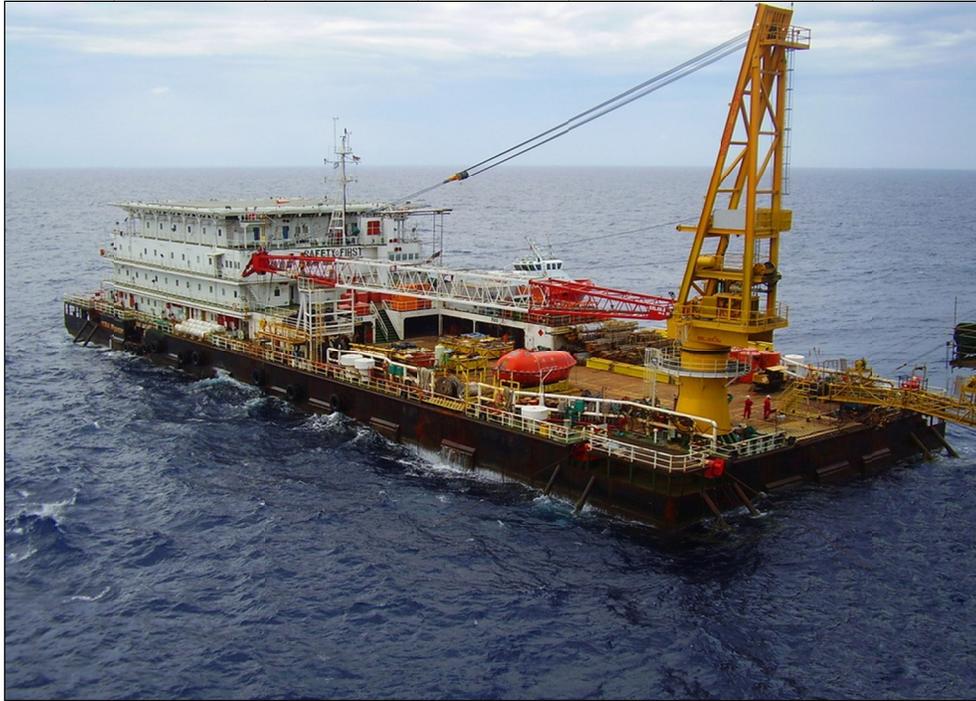
Figure 5.11. Pipeline lay-barge with anchors deployed (Shu 2011).

In addition to the impacts caused by jetting and laying the pipeline, substantial bottom-disturbing activities can also be caused by anchors and anchor chain used by the lay-barge during installation. A standard pipeline lay-barge extends anchors out a distance of five times the water depth. An anchored barge typically requires between eight and 12 anchors, each weighing between 30,000 to 50,000 tons (Cranswick 2001). The anchors are lifted onto anchor-handling support tugs which are used to deploy the anchors along the route. Winches aboard the lay-barge move the barge along the route by tightening up on the foreword anchors. Generally, after anchors are set, they need to be repositioned every 610 m (2,000 ft) along the pipeline route (Cranswick 2001). Ground disturbance is not limited to the actual anchor touch-down points. During barge movements, slack is placed on the stern lines before pulling the vessel forward along the bow anchor lines; this may allow portions of the chain to rest or drag on the bottom. The large diameter wire rope used to handle these massive anchors can cause substantial damage to a shipwreck site.

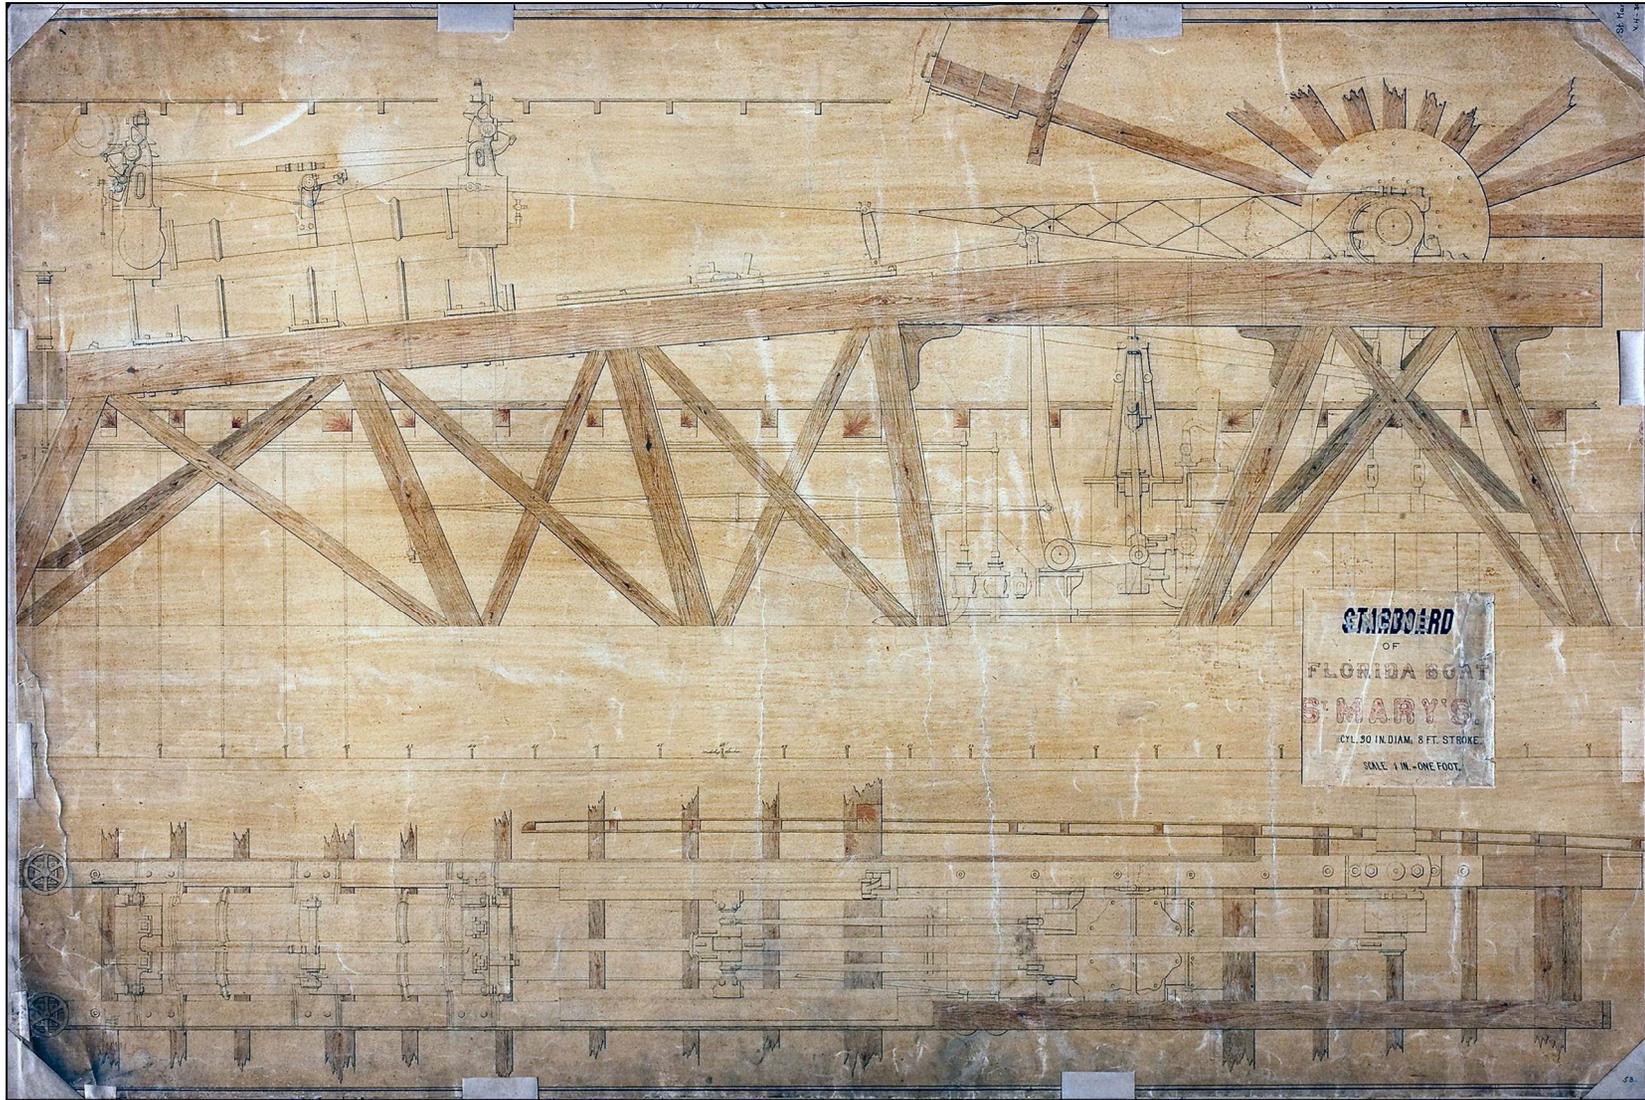
Figure E-39. Drawing of the engine for *St. Mary's*, Hull No. 41, date unknown, from the Harlan & Hollingsworth Collection, Mariner's Museum, Newport News, Virginia.

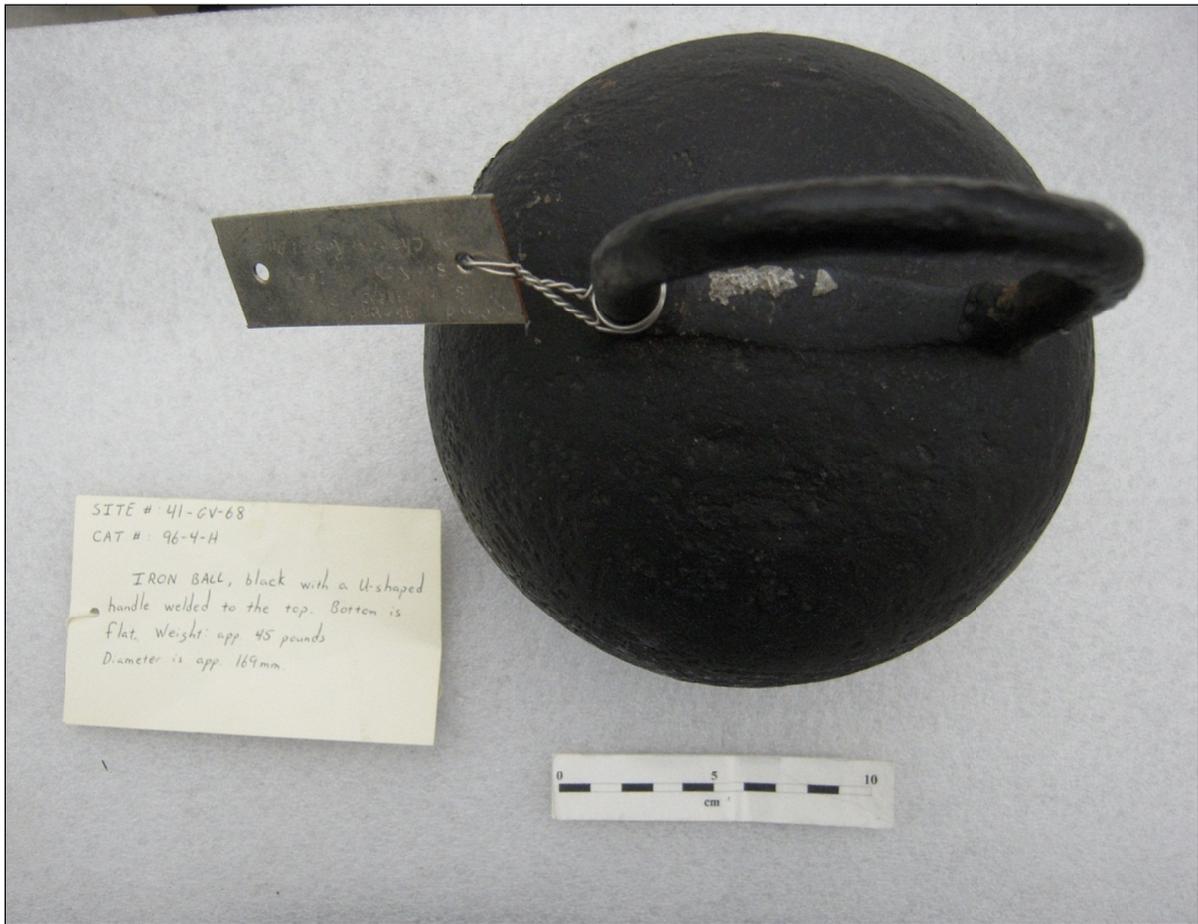
Figure E-41. Iron ball, shown from above, recovered from USS *Hatteras* site, housed at the Corpus Christi Museum of Science and History. Image courtesy of the Naval History & Heritage Command Underwater Archaeology Branch, Department of the Navy.

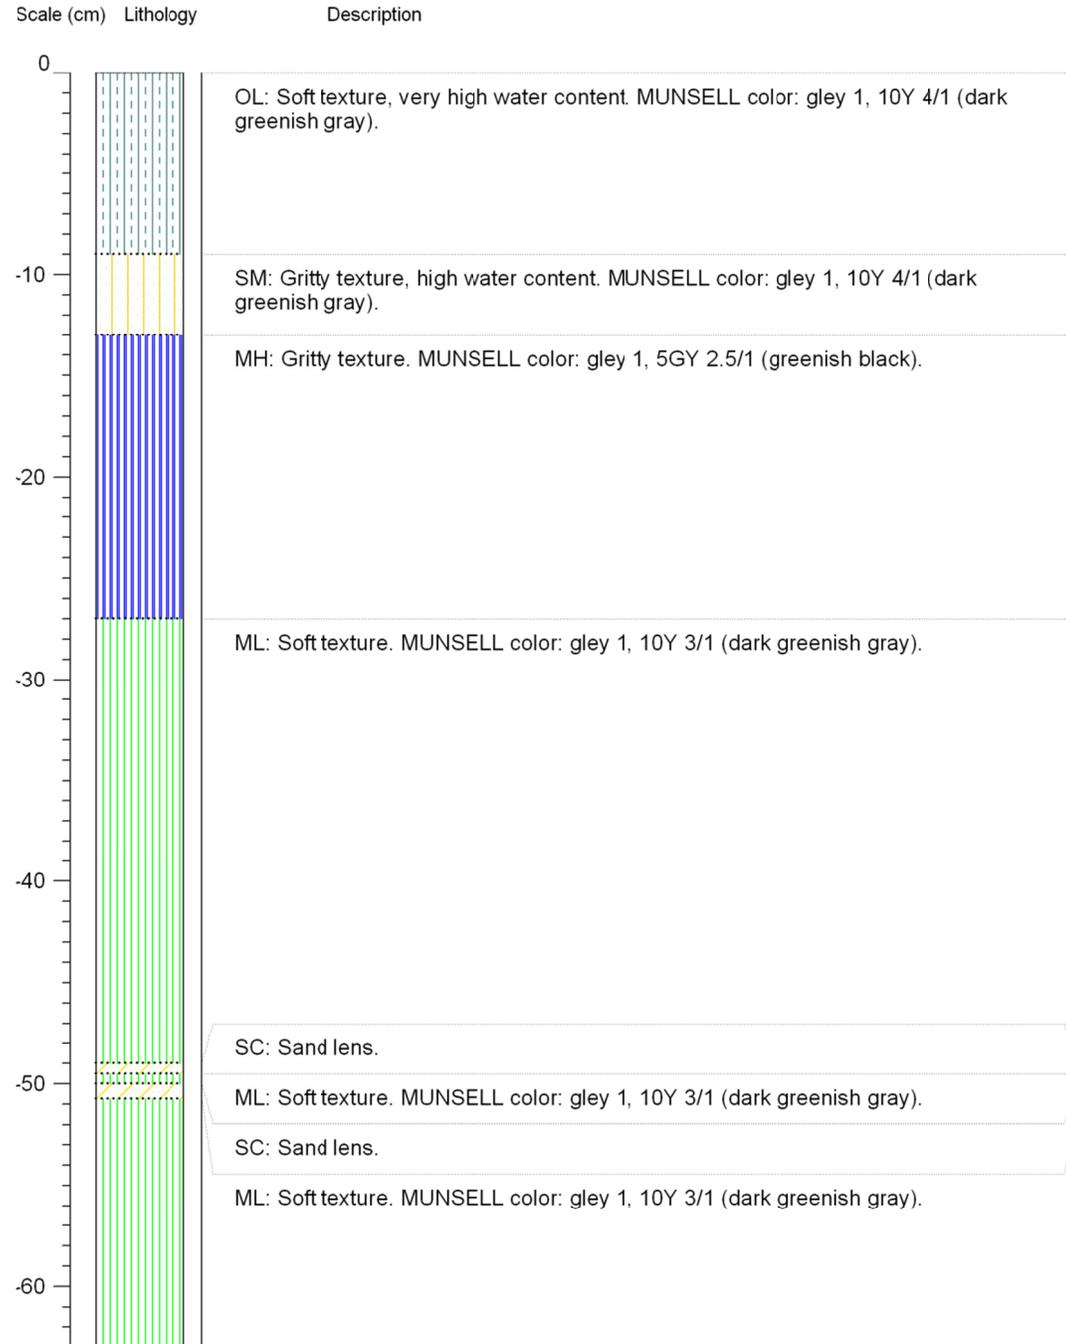
Core No. 1

Water Depth 20 m (66 ft) BSL

Site No. 389 (probable JA Bisso)

Collection Date 08/14/2010
